## Arm type ATC noise problem - position drum

This documentation describes the possible causes and the solutions for Arm Type ATC failures in the field. The most common error messages are:

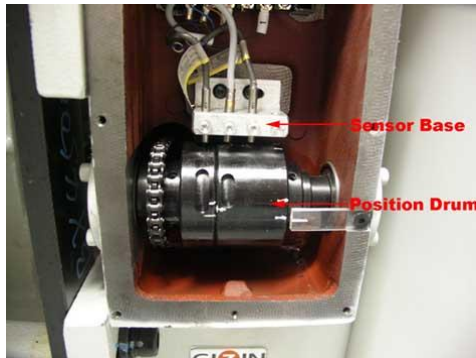
The position drum slots and sensors must be properly aligned to prevent errors. Figure below shows the location of the sensors and position drum; it is located at the front side of the machine on the swing arm unit. If the sensor base is misaligned horizontally with respect to the slots on the position drum, the sensors may read inconsistently. A technician can easily fix a misalignment by loosening two screws on the sensor base and adjusting sensor alignment.

Slots on the position drum can be misaligned with respect to each other as well. The ideal position of B slot is at the center of A slot. Distance 2 can be shorter than what it is supposed to be and cause the middle sensor to trip at an earlier stage of tool change, which results in failure messages. Figure below shows the slot position on the drum. A technician can resolve this by reversing the phases on the arm motor. This will change the direction of the position drum rotation, which gives more time for the arm to get into the correct position before the middle sensor trips.
